**Acoustic Systems
Acoustical Research Facility
Official Laboratory Report
AS-TL1734A**

Subject: Sound Transmission Loss Test

On:
**ArmorCore Level 4 Bullet Resistant Fiberglass Panels
(Thickness 1-3/8") Butt jointed with Batten Strip, Mechanically
Attached with sealant.**

For:
Waco Composites, Inc.

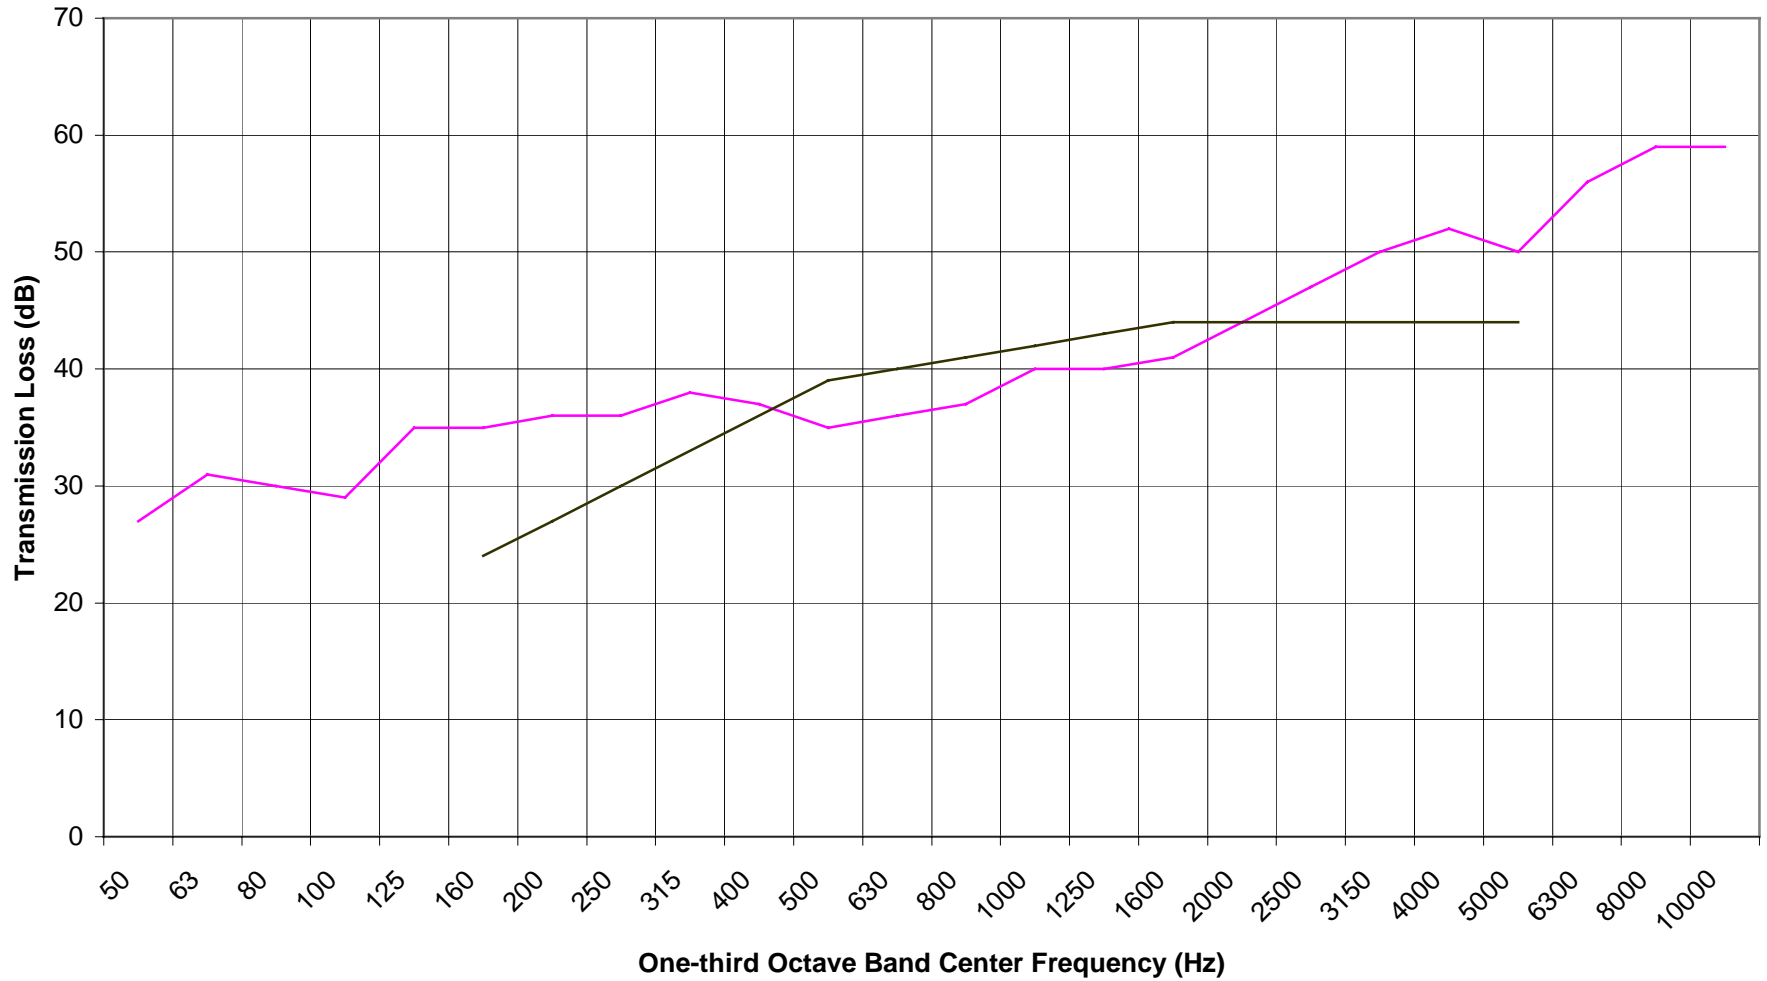
**Waco Composites, Inc. ArmorCore Level 4 Bullet Resistant Fiberglass Panels (Thickness 1-3/8") Butt Joined with Mechanically Attached Batten Strip w/Sealant AS-TL1734A; STC 40
OITC 37**

The Sound Transmission Loss of the test specimen at the preferred one-third octave band center frequencies is tabulated below and then presented graphically. Octave-band Transmission Loss values are calculated as described in section 12.4 of ASTM E90-97.

1/3 octave Band Center Freq. (Hz)	Transmission Loss (dB)	Uncertainty (+/-dB)	Notes	Octave Band TL (dB)	STC Deficiencies
50	27		[d][g]		
63	31		[d][g]	29	
80	30	1.7	[d][g]		
100	29	1.8			
125	35	2.6	[d]	32	
160	35	1.5			
200	36	0.7			
250	36	0.9		37	
315	38	0.6			
400	37	0.6			2
500	35	0.5		36	5
630	36	0.4			5
800	37	0.4			5
1000	40	0.4		39	3
1250	40	0.3			4
1600	41	0.2			3
2000	44	0.3		43	
2500	47	0.3			
3150	50	0.2			
4000	52	0.2		51	
5000	50	0.3			
6300	56	0.4			
8000	59	0.5		58	
10000	59	0.8	[a][c]		
STC	40				
OITC	37
