**Acoustic Systems  
Acoustical Research Facility  
Official Laboratory Report  
AS-TL1735**

Subject: **Sound Transmission Loss Test**

**ArmorCore Level 3 Bullet-Resistant Fiberglass Panels (Thickness 1/2")  
Butt Jointed with Batten Strip, Mechanically Attached**

**Waco Composites, Inc.**

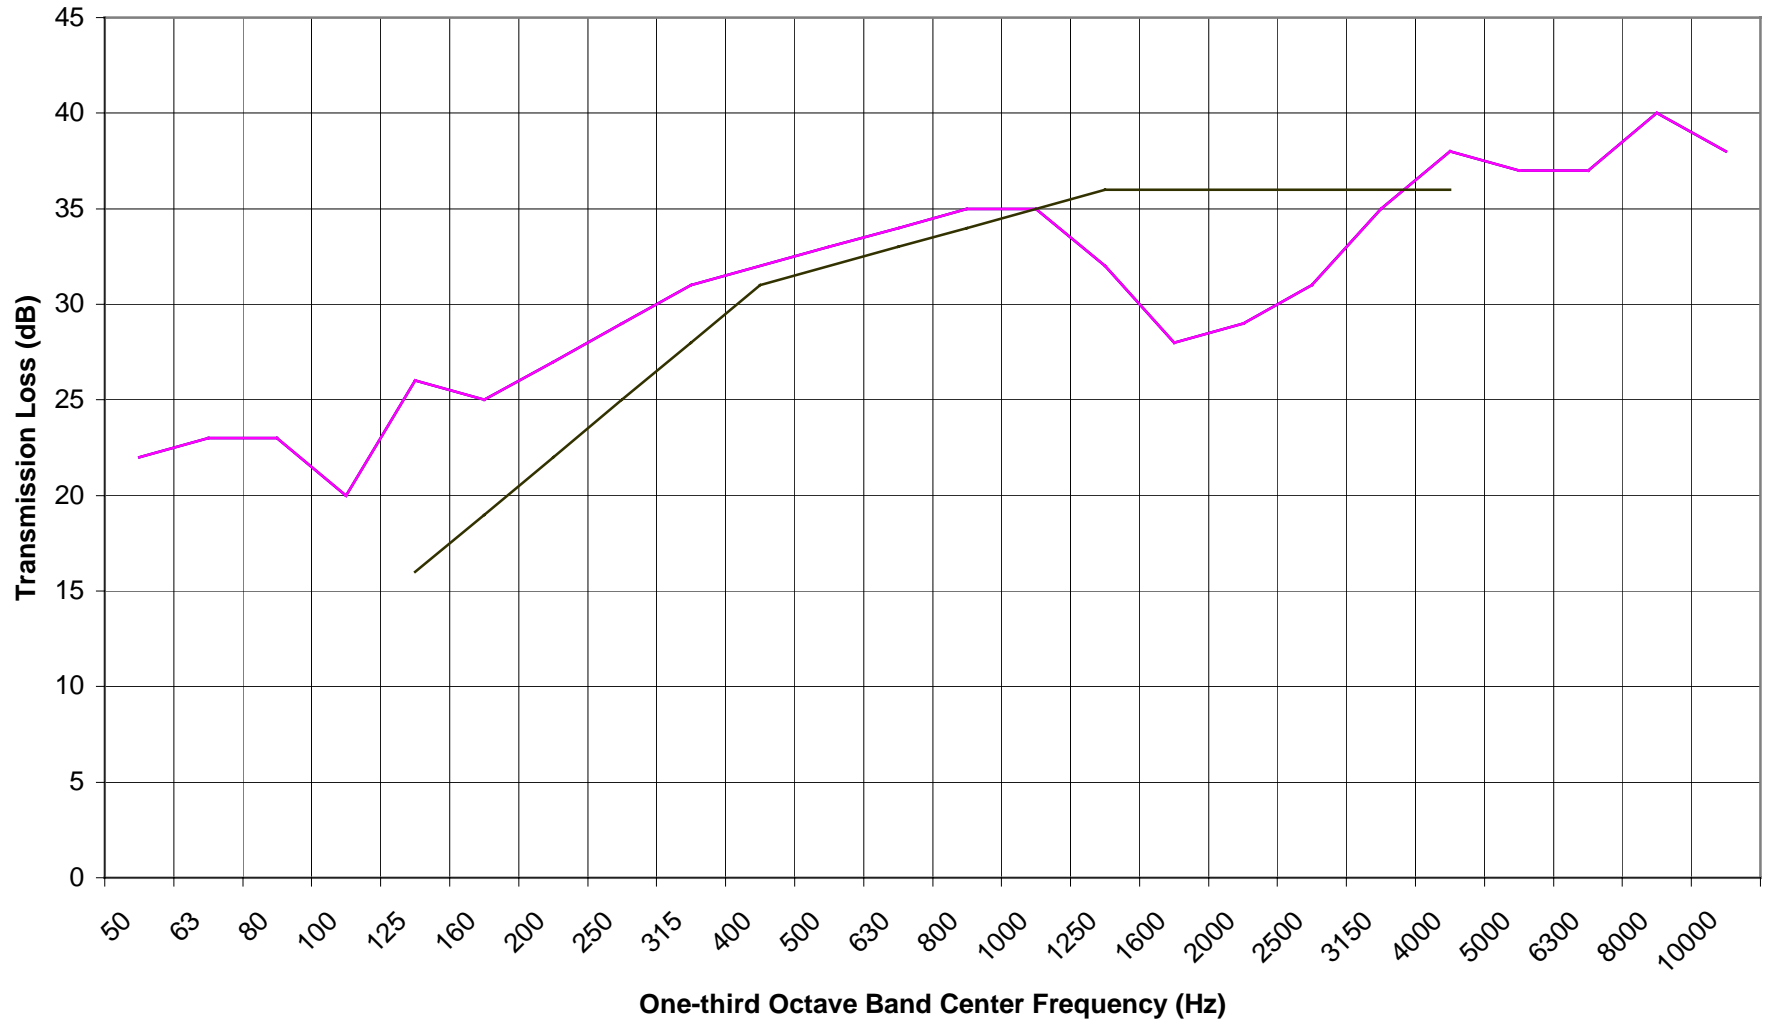
**Waco Composites, Inc. ArmorCore Level 3 Bullet-Resistant Fiberglass Panels (Thickness = 1/2") Butt Jointed with Batten Strip, Mechanically Attached AS-TL1735; STC 32 OITC 30**

<b>1/3 Octave Band Center Freq. (Hz)</b>	<b>Transmission Loss (dB)</b>	<b>Uncertainty (+/-dB)</b>	<b>Notes</b>	<b>Octave Band TL (dB)</b>	<b>STC Deficiencies</b>
<b>50</b>	22		[d][g]		
<b>63</b>	23		[g]	22	
<b>80</b>	23	1.8	[g]		
<b>100</b>	20	1.9			
<b>125</b>	26	2.5		23	
<b>160</b>	25	1.5			
<b>200</b>	27	0.7			
<b>250</b>	29	0.9		29	
<b>315</b>	31	0.6			
<b>400</b>	32	0.6			
<b>500</b>	33	0.5		33	
<b>630</b>	34	0.4			
<b>800</b>	35	0.4			
<b>1000</b>	35	0.4		34	
<b>1250</b>	32	0.3			4
<b>1600</b>	28	0.2			8
<b>2000</b>	29	0.3		29	7
<b>2500</b>	31	0.3			5
<b>3150</b>	35	0.2			1
<b>4000</b>	38	0.2		36	
<b>5000</b>	37	0.3			
<b>6300</b>	37	0.4			
<b>8000</b>	40	0.5		38	
<b>10000</b>	38	0.8			
<b>STC</b>	<b>32</b>				
<b>OITC</b>	<b>30</b>
