**Acoustic Systems
Acoustic Research Facility
Official Laboratory Report
AS-TL1735A**

Subject: **Sound Transmission Loss Test**

**ArmorCore Level 3 Bullet-Resistant Fiberglass Panels (Thickness ½")
Butt Jointed with Mechanically Attached Batten Strip w/Sealant**

Waco Composites, Inc.

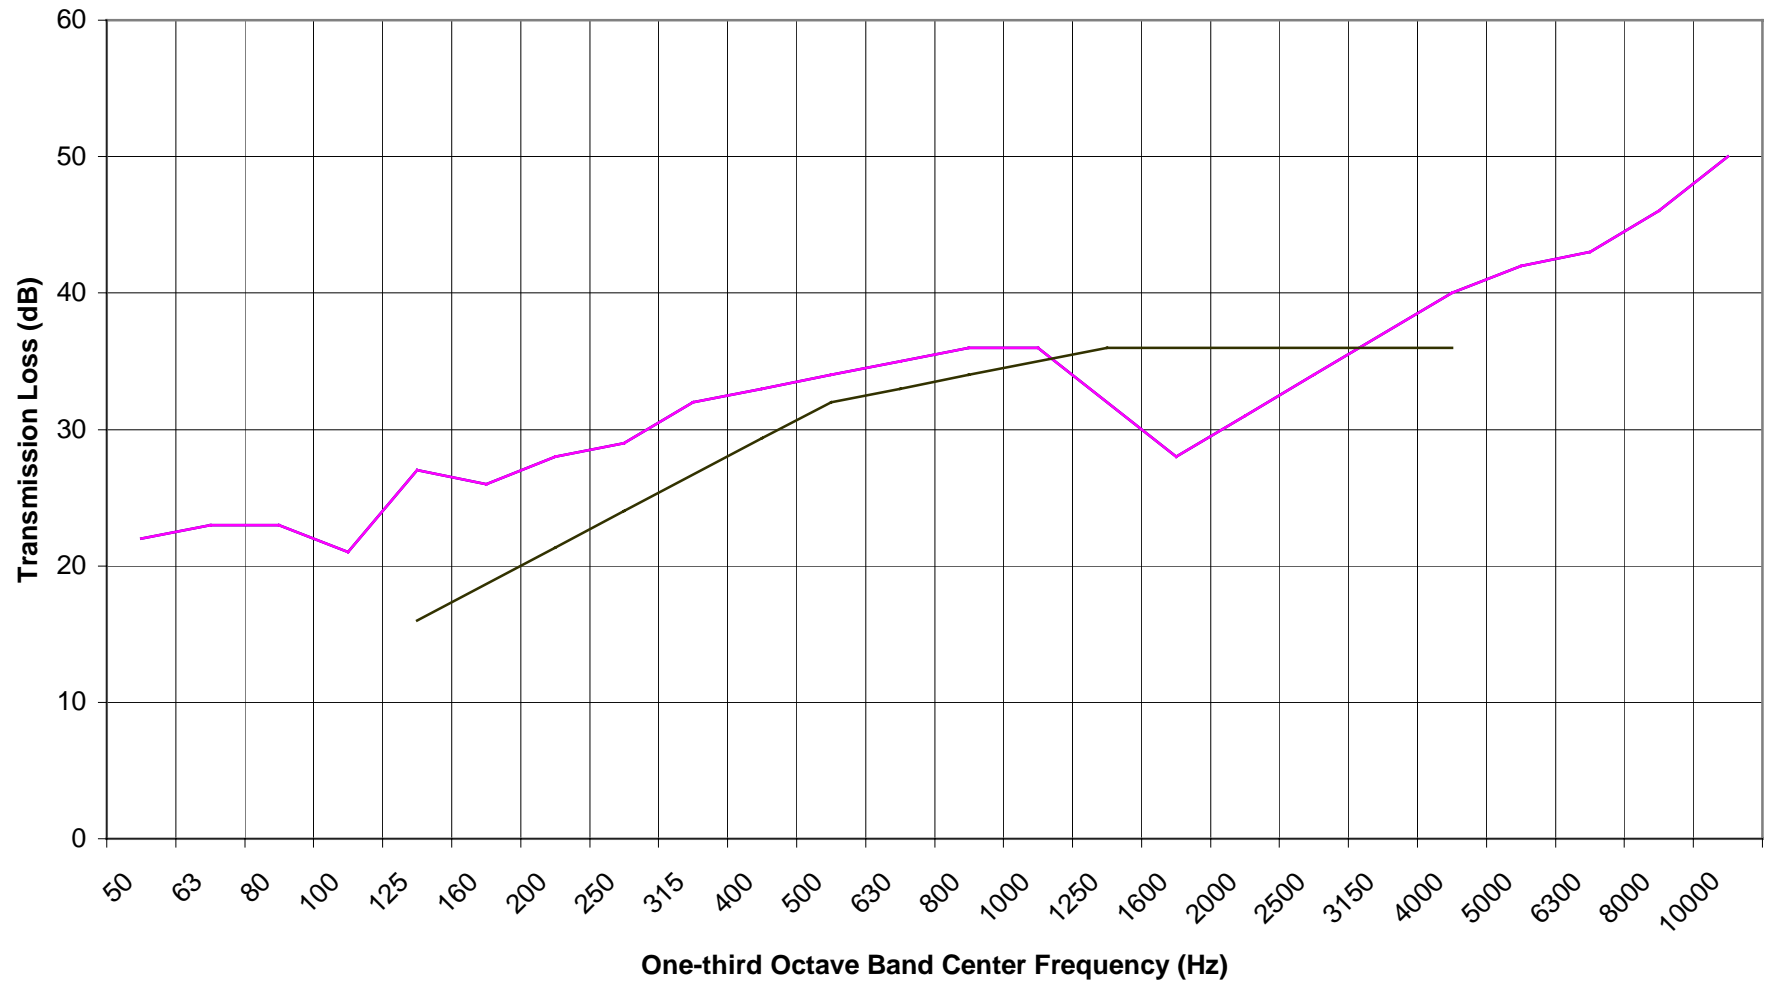
**Waco Composites, Inc. ArmorCore Level 3 Bullet-Resistant Fiberglass Panels (Thickness 1/2") Butt Jointed with Mechanically Attached Batten Strip w/Sealant AS-TL1735A; STC 32
OITC 30**

The sound Transmission Loss of the test specimen at the preferred one-third octave band center frequencies is tabulated below and then presented graphically. Octave-band Transmission Loss values are calculated as described in Section 12.4 of ASTM E90-97.

1/3 Octave Band center Freq. (Hz)	Transmission Loss (dB)	Uncertainty (+/-dB)	Notes	Octave Band TL (dB)	STC Deficiencies
50	22		[d][g]		
63	23		[g]	22	
80	23	1.8	[g]		
100	21	1.9			
125	27	2.6		24	
160	26	1.5			
200	28	0.7			
250	29	0.9		30	
315	32	0.6			
400	33	0.6			
500	34	0.5		34	
630	35	0.4			
800	36	0.4			
1000	36	0.4		34	
1250	32	0.3			4
1600	28	0.2			8
2000	31	0.3		30	5
2500	34	0.2			2
3150	37	0.2			
4000	40	0.2		39	
5000	42	0.4			
6300	43	0.4			
8000	46	0.5		46	
10000	50	0.8			
STC	32				
OITC	30
